THERMAL 3Ht....Saving Energy, One Steel Building at a Time.

"Green" Steel Construction in the 21st Century

INFRARED IMAGES STEEL WALL ASSEMBLY ASTM 1363-05

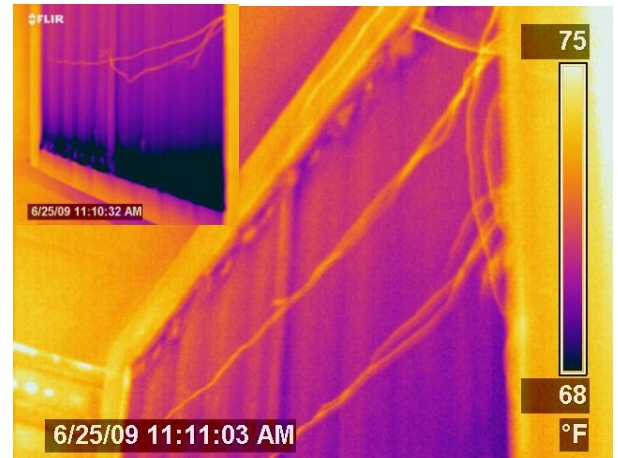
Actual infrared images (I.R.) of two actual ASTM 1363-05 wall assemblies

6" Steel Wall - R-19 Fiberglass & 1/2" Thermal 3Ht

- Inset pictures on the top left corner of both infrared images are actual I.R. images of the bottom left hand corner of each wall assembly
- Color of infrared imaging is relative to the overall temperature range of the object.
- Wall 1 - 13 degrees difference in temperature from its coldest point to its warmest point
- Wall 2 - there is only 7 degrees difference from its coldest point to its warmest point
- Wall 2 - at its coldest point Wall 2 is 11 degrees warmer than Wall 1
- Wall 2 - at its warmest point, Wall 2 is 5 degrees warmer than Wall 1 and the controlled inside temperature setting of 70 degrees. Why is this happening? Is Thermal 3Ht reflecting radiant heat back to its source warming up the surface of the interior steel liner panel!? Probably!
